### **36. Site 36 at RM 217.5 RDB (Pool 26)**

### **36a. Observation Site at RM 200.2 RDB (Pool 27)**

### ***37. Site 37 at RM 197.6 RDB (Pool 27)***

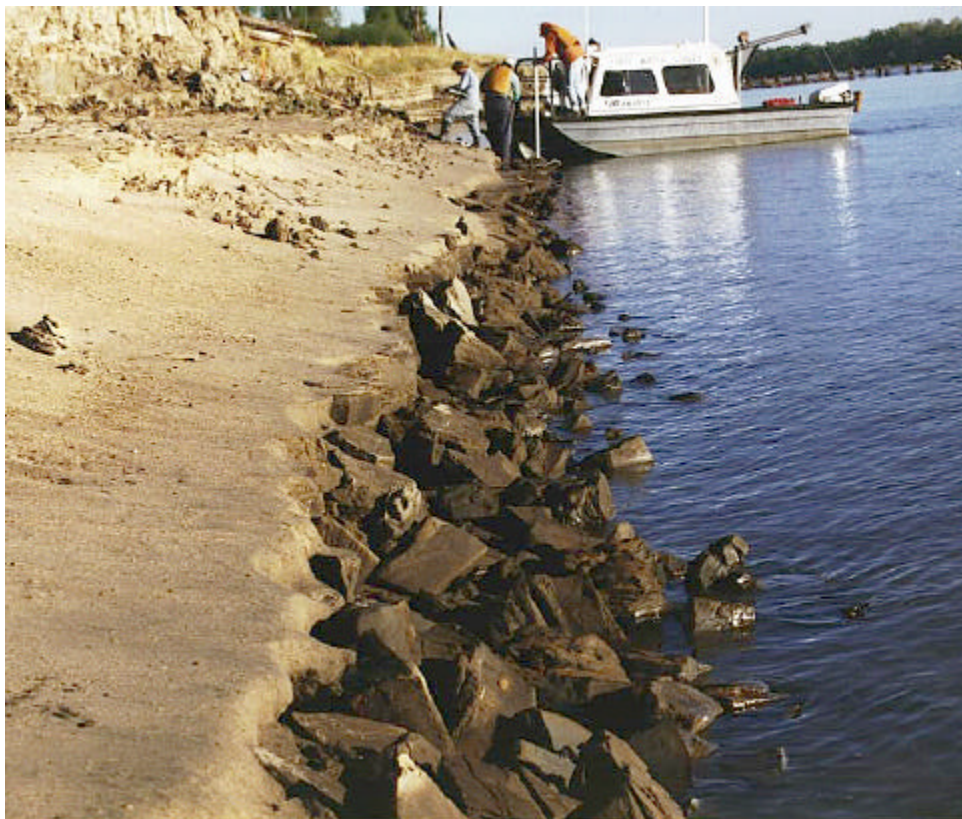
This left-bank site, shown in figure 7-124, is located inside a bend on a small island. Photos 7-107 and 7-108 show upstream and downstream views of the site, respectively. Photo 7-109 shows eroded bank near the tip of the island and Photo 7-110 shows a close-up view of eroded bench. Although the site map does not show this bank to be on an island, erosion along the left bank at about RM 112.5 had formed a small island. The back channel of this island meets the MR at around RM 111.6. There are several large wing dams, and this erosion site is located between two wing dams. Around the upstream tip of the island, flow velocities toward the back channel were estimated to be about 8 ft/s. These flows are eroding the island. This erosion along the concave bank was initiated by the Great Flood of '93. The back channel apparently was eroded deeply during the flood, creating a large differential head between the main MR channel and the slough.

**Photo 7-110 A close-up view of eroded bench at Site 39 midpoint**

Causative factors for bank retreat at this site include flood-flow erosion, impacts by flow-control structures, piping and failures, and wave and rework-transport of failed soils and recently deposited sediments within berm and bench areas. Although the thalweg sailing line is far from this site, silty sand deposits are eroded by waves. A combination of Types A, B, and C characterizes Site 39.
